Ocean Engineering Studies

Volume I: Acrylic Submersibles

**DEVELOPMENT OF A SPHERICAL
ACRYLIC PLASTIC PRESSURE HULL
FOR HYDROSPACE APPLICATION**

April 1970

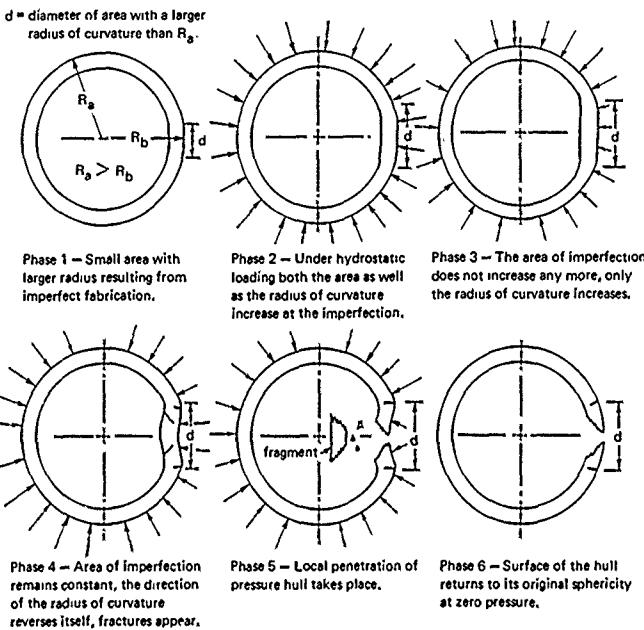
Figure 89. Mechanism of localized viscoelastic failure in an acrylic plastic hull under sustained external hydrostatic pressure.

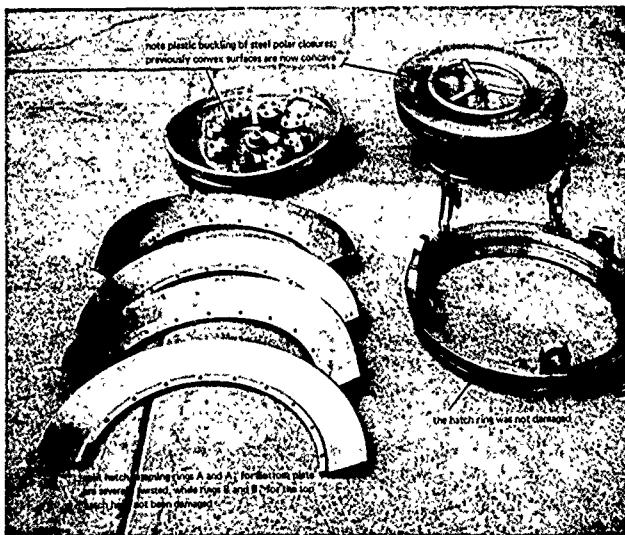
Figure 118. Steel polar closure components from the imploded 66-inch-diameter capsule.

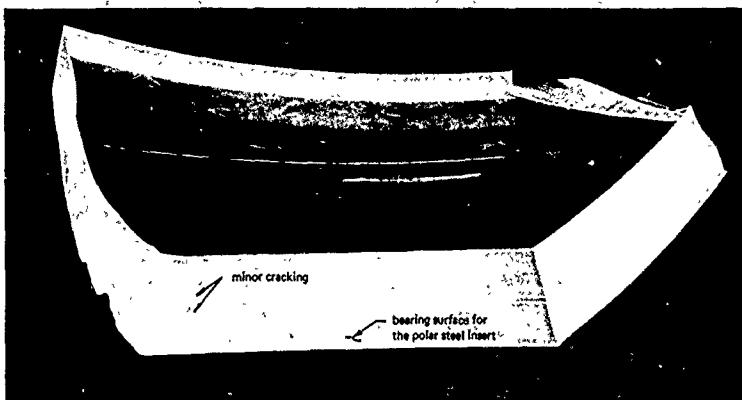
Figure 119a. Fragment from the top polar acrylic plastic pentagon. Note that the beveled bearing surface shows only minor cracking at the location that corresponds to the O-ring groove on the hatch ring.

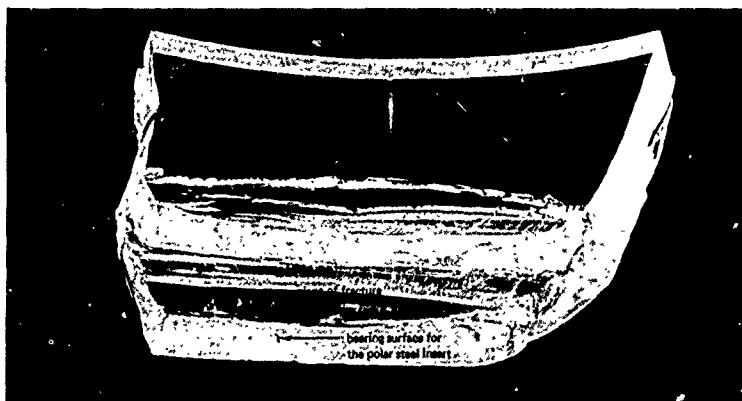
Figure 119b. Fragment from the bottom polar acrylic plastic pentagon. Note that serious spalling has taken place on the beveled bearing surface initiated at the location that corresponds to the O-ring groove on the bottom steel plate. Mechanism of failure is shown in Figure 119c.

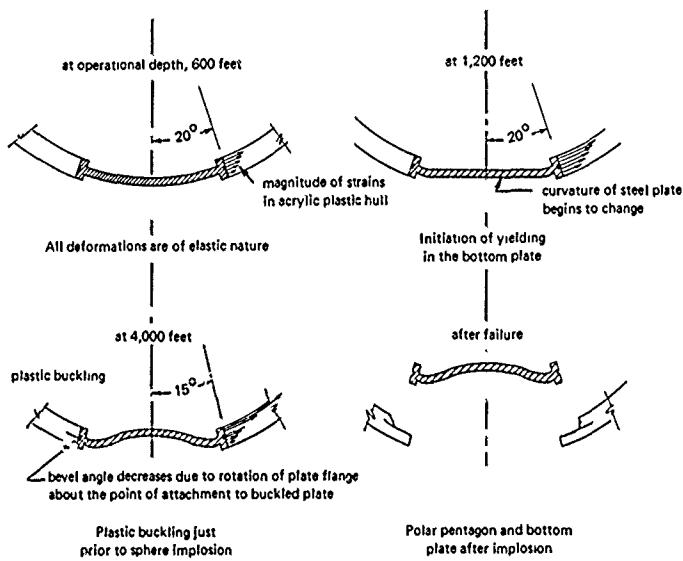
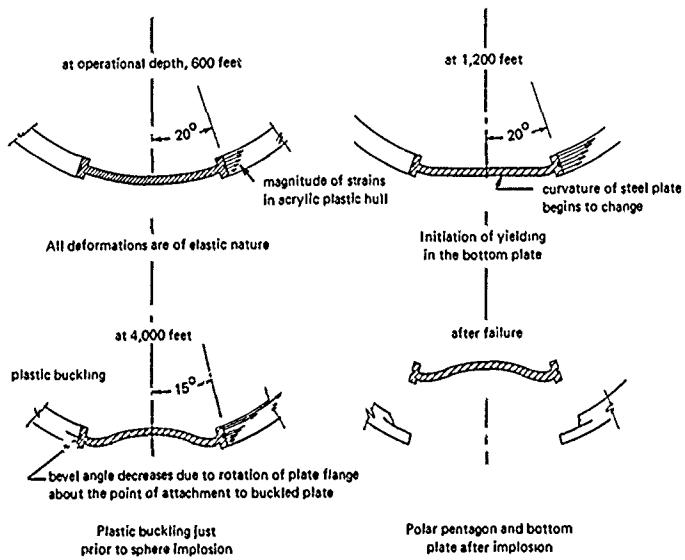
Figure 119c. Mechanism of failure by spalling in the bottom polar acrylic plastic pentagon reconstructed from observation of deformation in the bottom steel plate and fracture in the bottom polar acrylic plastic pentagon.

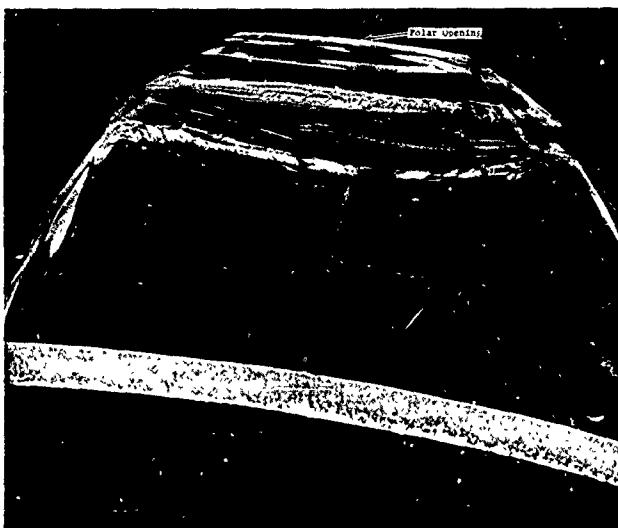
Figure 34a. Fragment from the polar pentagon in contact with the bottom steel penetration plate; exterior surface.

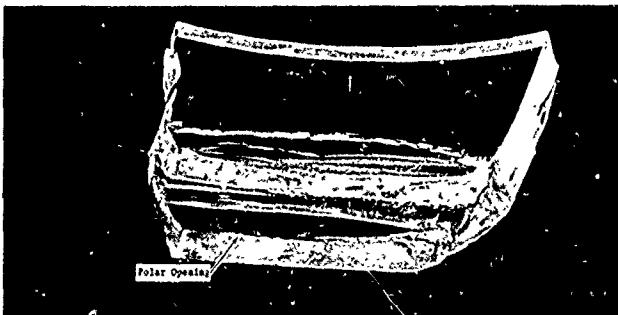
Figure 34b. Fragment from the polar pentagon in contact with the bottom steel penetration plate; interior surface. Note extensive spalling on the acrylic bearing surface in contact with steel plate.

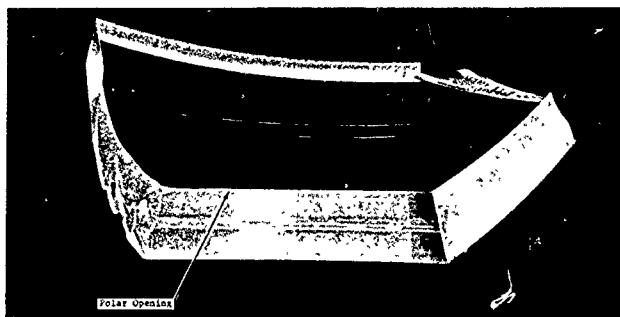
Figure 35a. Fragment from the polar pentagon in contact with the top hatch ring; interior surface. Note only minor cracking on the acrylic bearing surface.

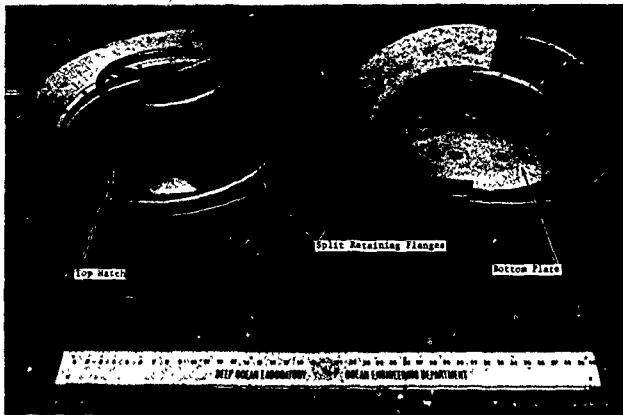
Figure 36a. Plastically deformed steel parts from the imploded NEMO hull.

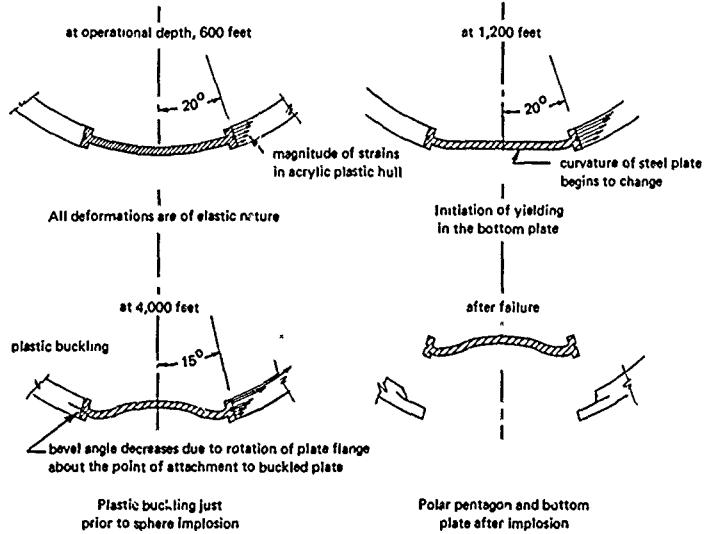
Figure 36b. Mechanism of spalling in the bottom polar acrylic pentagon reconstructed from observation of deformation in the bottom steel plate and fracture in the bottom polar acrylic pentagon.

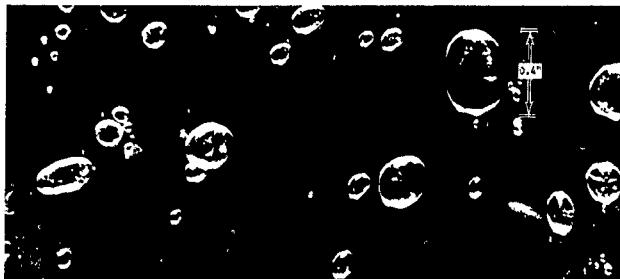
Figure 37a. Typical air cavities in the NEMO joints bonded with PS-18 self-polymerizing adhesive.

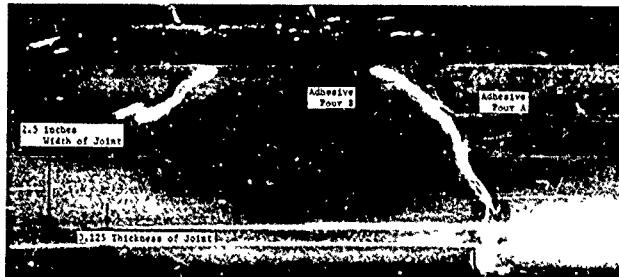
Figure 37b. Typical joint discontinuity at the interface of two successive adhesive pours.

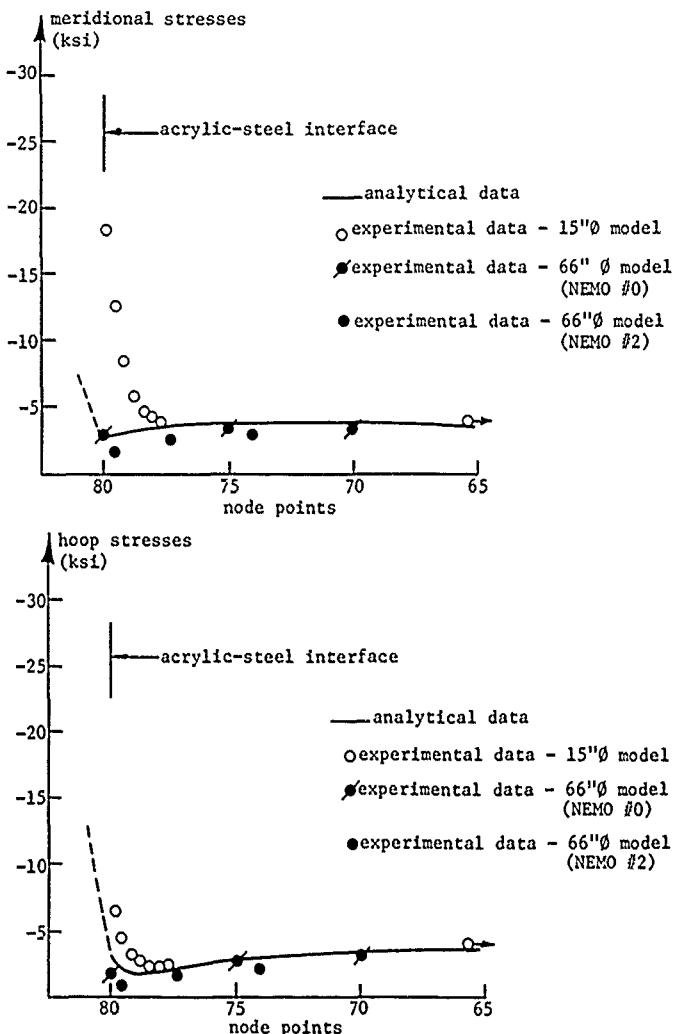
Experimental data obtained from the testing of two 66" diameter NEMO prototypes has also been included in Figures 3 and 4. It may be observed that the data obtained from the prototypes is in excellent agreement with the analytical results, whereas the data obtained from the model reveals a substantial stress concentration within two node points (0.07 radians) of the hatch. This discrepancy may be attributed to (1) differences in hatch design, and (2) different hatch placement procedures for model and prototype. Figure 5 shows the prototype, model, and the analytically simulated hatch designs. The different conditions prevailing at the acrylic to steel transition in the three cases may clearly be observed. The most gradual transition seems to have been incorporated in the prototype design due to the presence of the neoprene gaskets and the retaining flanges (Figure 5a). The hatch placement procedure for the 66" diameter prototype involves a tightening of the bolts connecting the retaining flange to the hatch ring. This "pre-tensioning" will also tend to provide for a continuous transfer of stresses between the acrylic and steel portions of the hatch. The design of the 15" diameter model, on the other hand, does not include the gasket and the retaining flange. Furthermore, the hatch is secured, initially, by a set of tension springs, the effects of which are relaxed when the sphere deforms under hydrostatic loading. Thus, a lower degree of structural continuity appears to be provided in the hull to hatch transition in the case of the 15" diameter model.

Figure 3. Comparison of Analytically and Experimentally Determined Stresses on External Surface of NEMO Hull in Immediate Vicinity of Hatch Opening; 500 psi Hydrostatic Pressure.

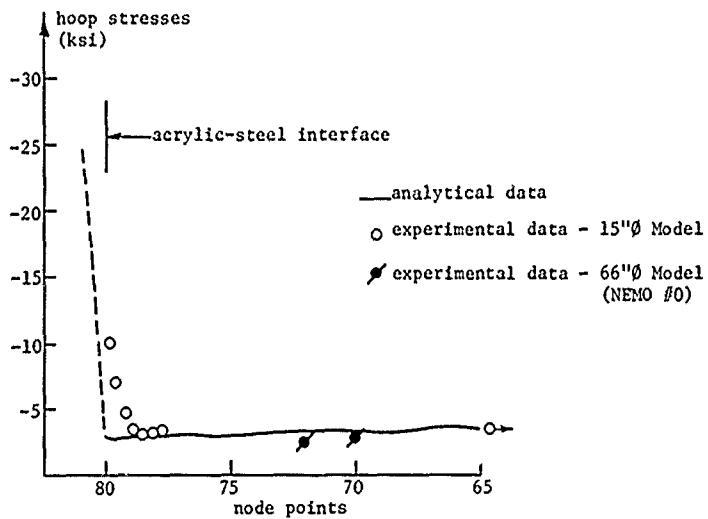
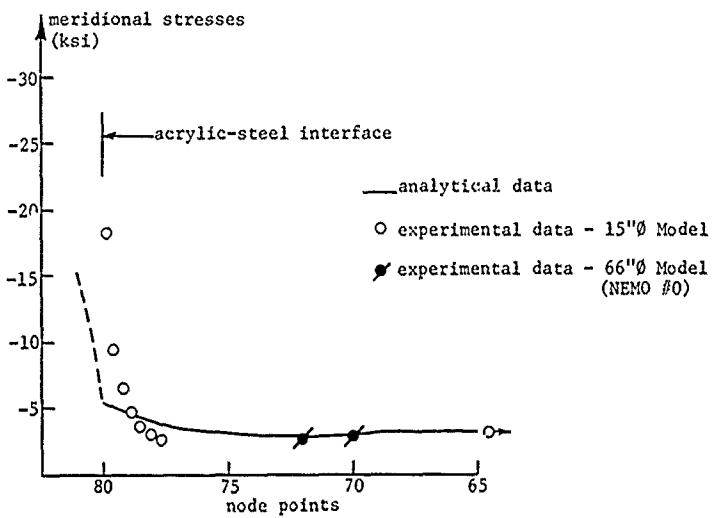
Figure 4. Comparison of Analytically and Experimentally Determined Stresses on Internal Surface of NEMO Hull in Immediate Vicinity of Hatch Opening; 500 psi Hydrostatic Pressure.

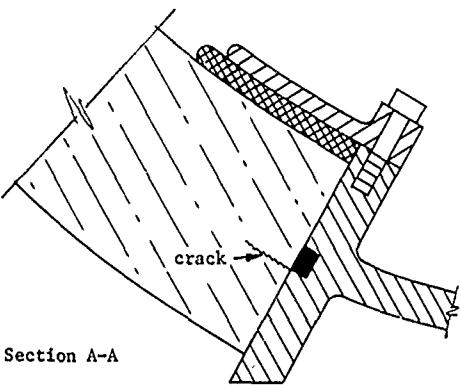
Bottom View of Polar
Opening for the Bottom
Penetration Plate

Several cracks of 0.250-inch penetration, 0.500-inch length, and less than 0.001-inch width were found in the acrylic plastic bearing surface in contact with the bottom steel penetration closure. The cracks were located around the circumference of the polar opening in the midplane of the hull wall. In all cases, these cracks originated at the bearing

Figure 13. Appearance of first cracks at the conclusion of Phase 2 cyclic tests.

surface and their penetrations were oriented at right angle to it. As the cracks penetrated further they tended to follow the curvature of the hull. The cracks were located in the same place and were of the same shape as those in the 15-inch NEMO models tested in the previous study. No cracks or crazing was observed in the adhesive filled joints and the voids there did not enlarge or serve as crack initiators.

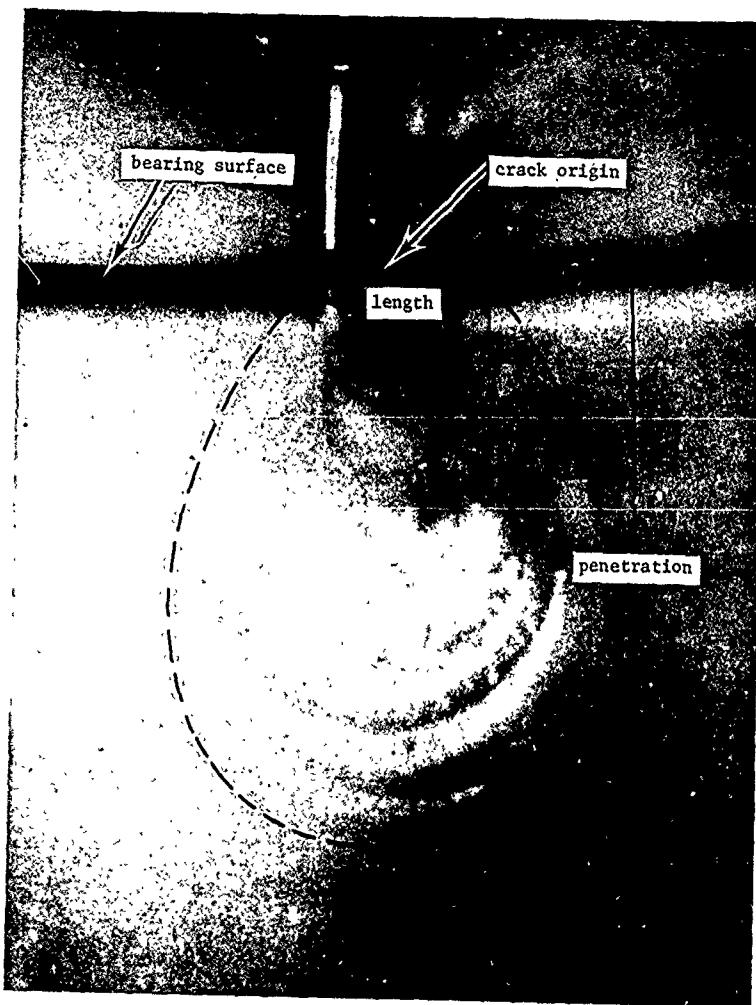
Figure 16. Detail of a typical crack shown in Figures 14 and 15.

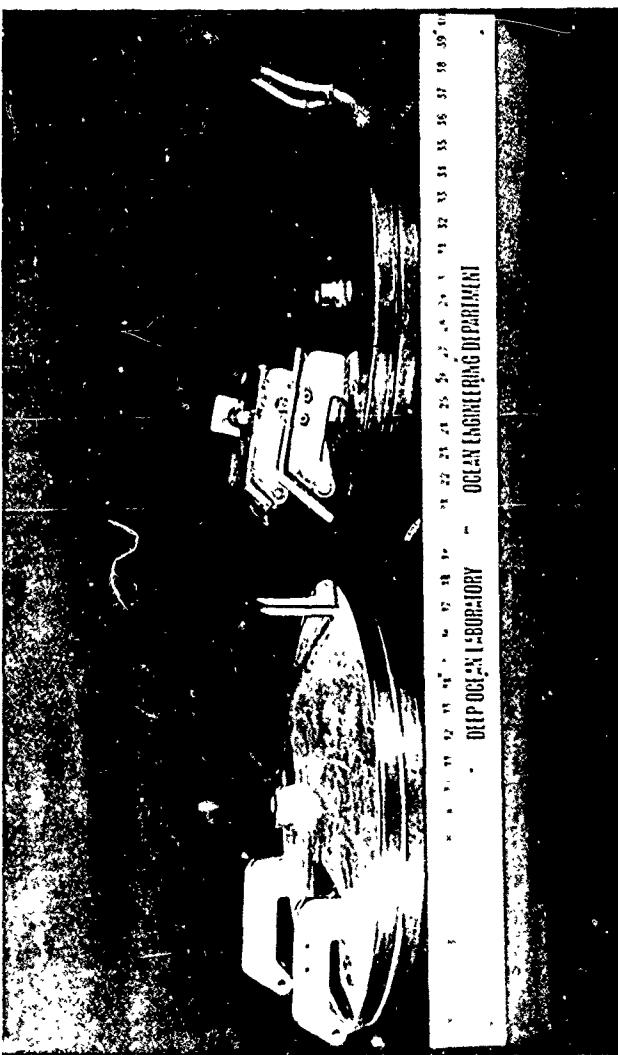
The top hatch exhibited typical plastic buckling of sufficient magnitude to result in complete reversal of hatch curvature (Figure 18). Where previously the hatch was convex, now it is concave. No cracks were observed in the plastically buckled hatch and the cadmium plating did not spall off from the yielded steel.

Figure 18. Comparison between the plastically buckled and a brand new hatch of annealed 4130 steel for NEMO Model 600 capsule.

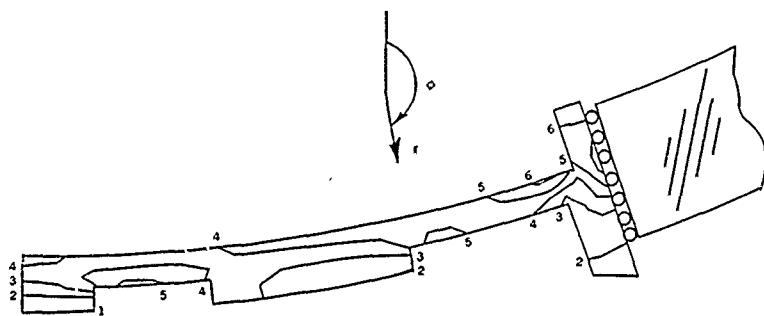
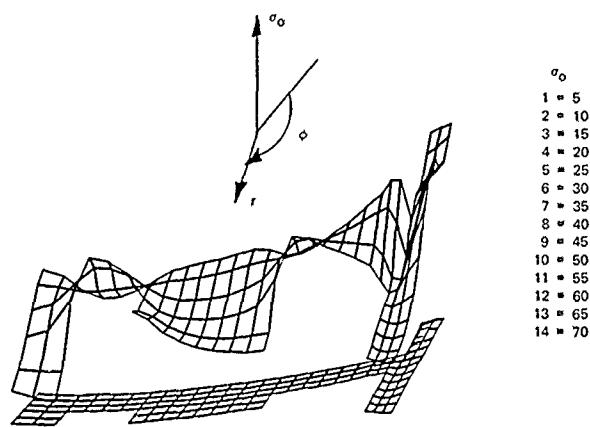
Figure 19. Effective stress contour and surface plots for bottom plate for free boundary condition.

The fixed and free cases for the steel top hatch are shown in Figures 16 and 17. It is evident from both figures that the bending in the top hatch produces high effective stresses in the "neck" section. The effective stress contour and surface plots for the bottom plate are shown in Figures 18 and 19 for both fixed and free boundary conditions. The bottom plate exhibits some bending, but the maximum value occurs as a bearing stress on the flange with a fixed boundary condition.

6. Increase thickness of bottom plate flange and eliminate scallops. Figures 18 and 19 indicate the presence of high stresses in the flange of the bottom plate. It is therefore necessary to increase the flange thickness (and thereby its stiffness) to about 1 inch to reduce the stresses. Elimination of the scallops is based solely on economic factors. They serve no useful purpose and require considerable more time and cost to machine.

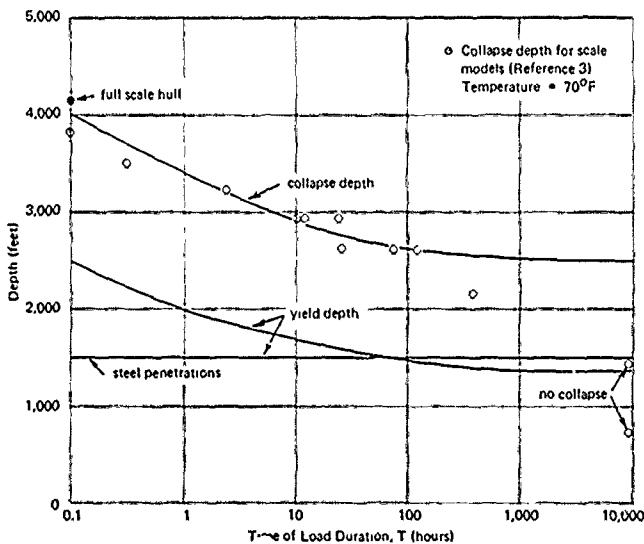
Figure 20. Yield depth and collapse depth curves for the acrylic plastic spherical pressure hull.

As Figure 20 indicates, yielding always occurs before the catastrophic stability failure of the hull. With a temperature of 70°F, and a load duration of 50 hours, the 66-inch OD acrylic plastic hull with 2-1/2-inch thick walls can operate to 1,000 feet with a safety factor of 1.5 based on yield and a safety factor of 2.6 based on collapse.

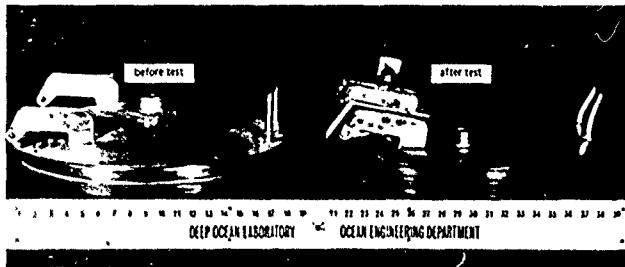
Figure 21. Top hatch after test of full-scale hull to 2,000 feet.

Figure 21 shows a before-test and after-test picture of the AISI 4130 steel top hatch. Notice the complete reversal of curvature in the hatch after the test to 2,000 feet. The hatch yielded without collapse of the hull, which appears to verify the 1,500-foot yield depth. Although Table 1 indicates yielding in the bottom plate, this is probably not actually the case because of the increased material in the flange due to the retainer ring. Any significant deformation of the bottom-plate flange would probably require shearing of the retainer-ring bolts.
